**UNITED STATES AIR FORCE  
JOINT BASE ELMENDORF-RICHARDSON,  
ALASKA**

*ENVIRONMENTAL RESTORATION PROGRAM*

**FOURTH CERCLA FIVE-YEAR REVIEW  
REPORT**

**JBER-ELMENDORF, ALASKA**

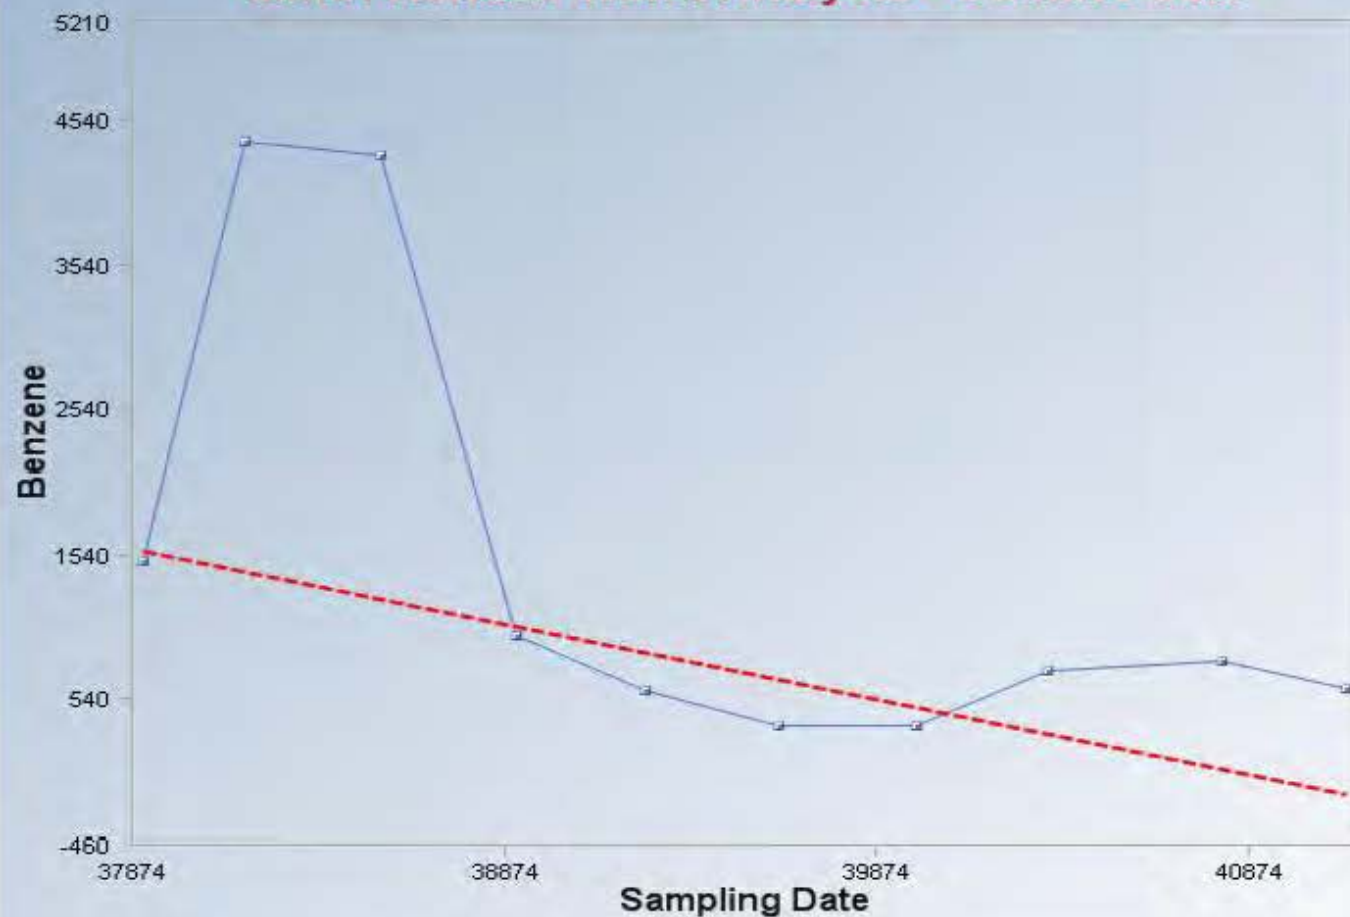
## Mann-Kendall Trend Analysis - OU4MW-08R

n	10.0000
Confidence Coefficient	0.9500
Level of Significance	0.0500
Test Value (S)	-19
Tabulated p-value	0.0540
Standard Deviation of S	11.1803
Standardized Value of S	-1.6100
Approximate p-value	0.0537

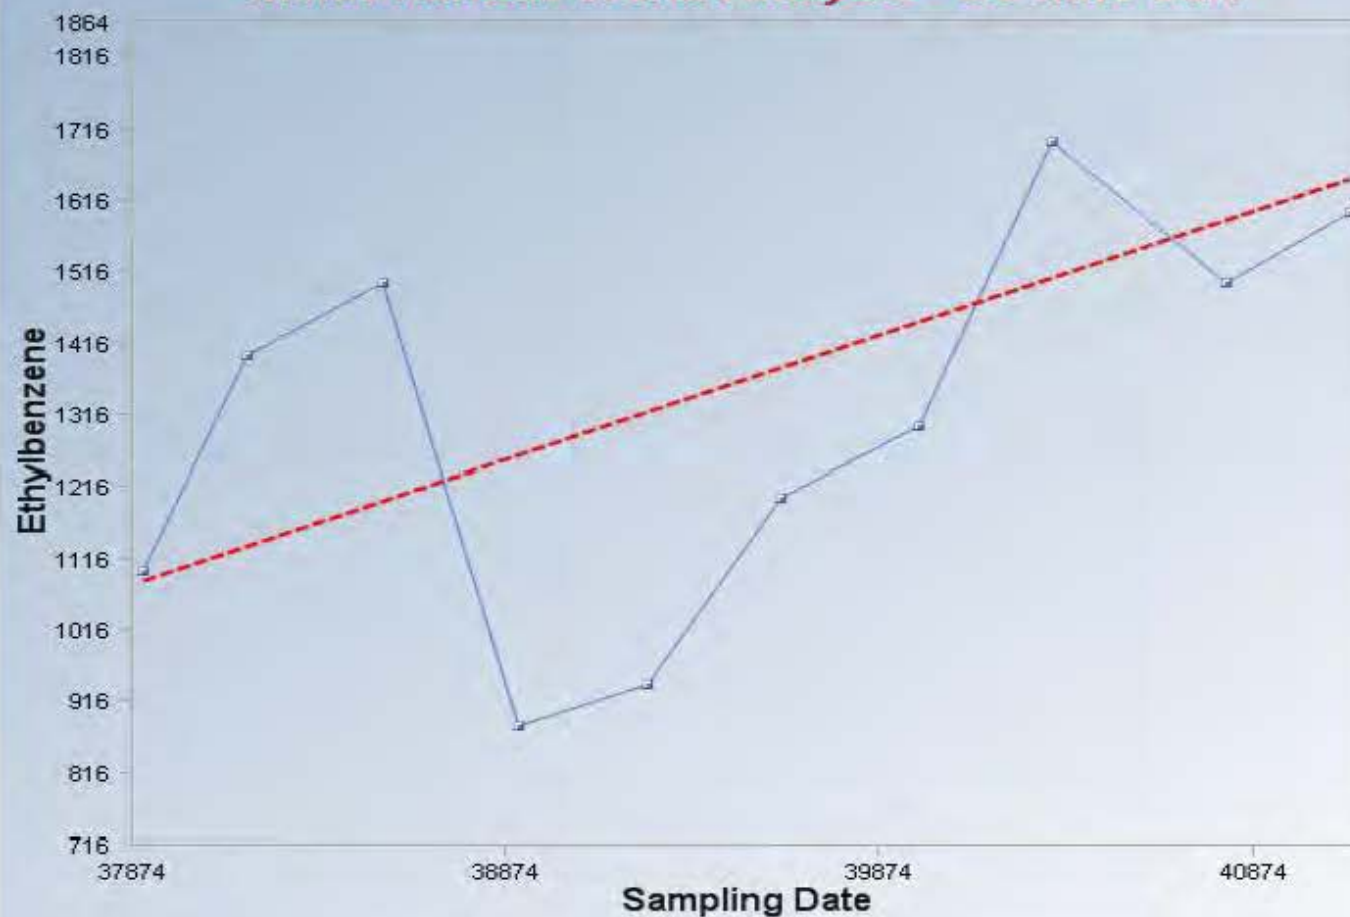
## Mann-Kendall Trend Analysis - OU4MW-08R

n	10.0000
Confidence Coefficient	0.9500
Level of Significance	0.0500
Test Value (S)	20
Tabulated p-value	0.0360
Standard Deviation of S	11.1355
Standardized Value of S	1.7063
Approximate p-value	0.0440

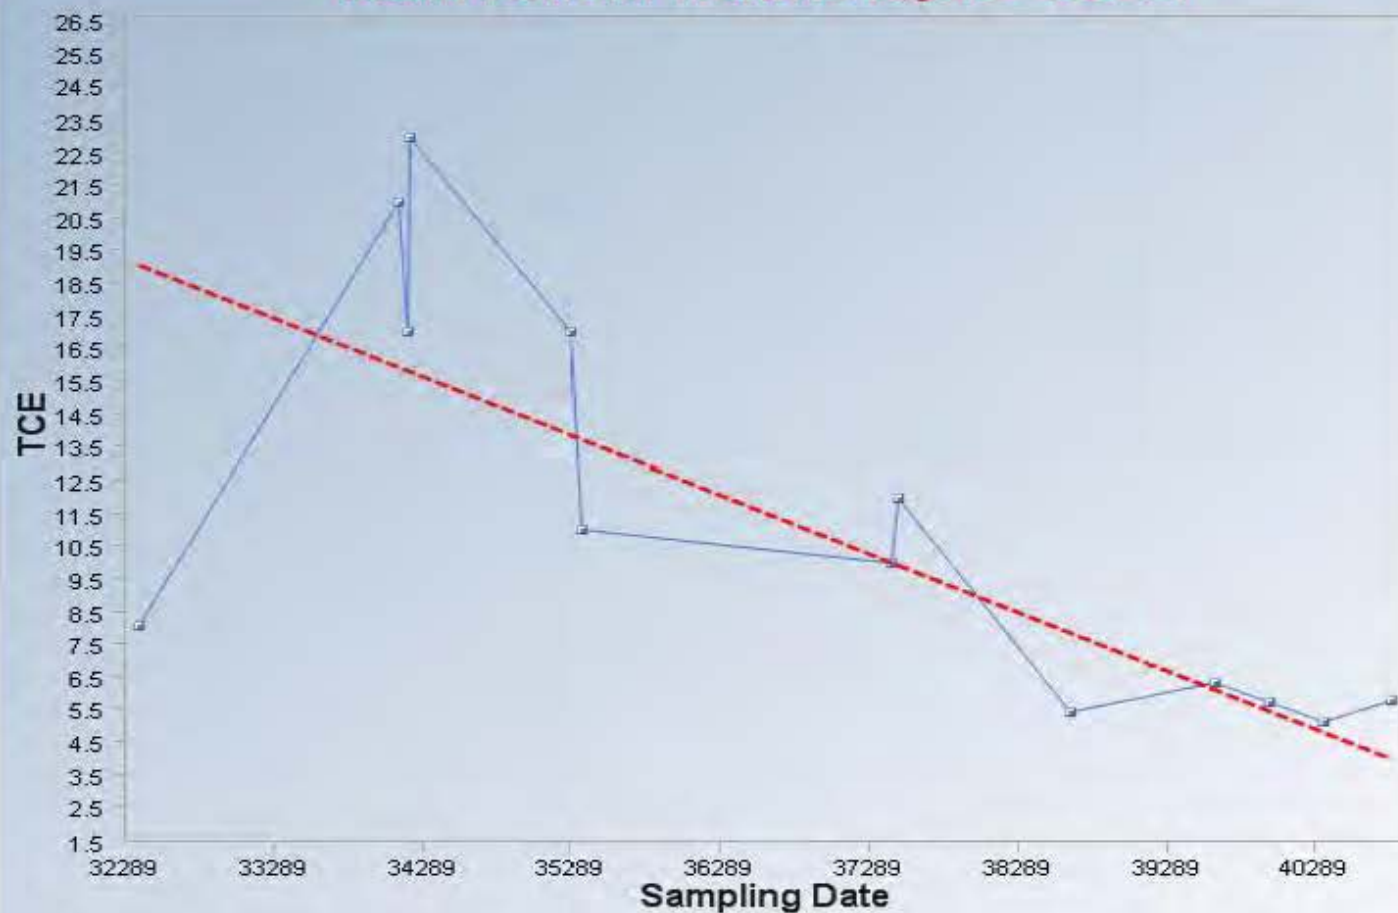
## Mann-Kendall Trend Analysis - IS6-01

n	13.0000
Confidence Coefficient	0.9500
Level of Significance	0.0500
Test Value (S)	-45
Tabulated p-value	0.0030
Standard Deviation of S	16.3605
Standardized Value of S	-2.6894
Approximate p-value	0.0036

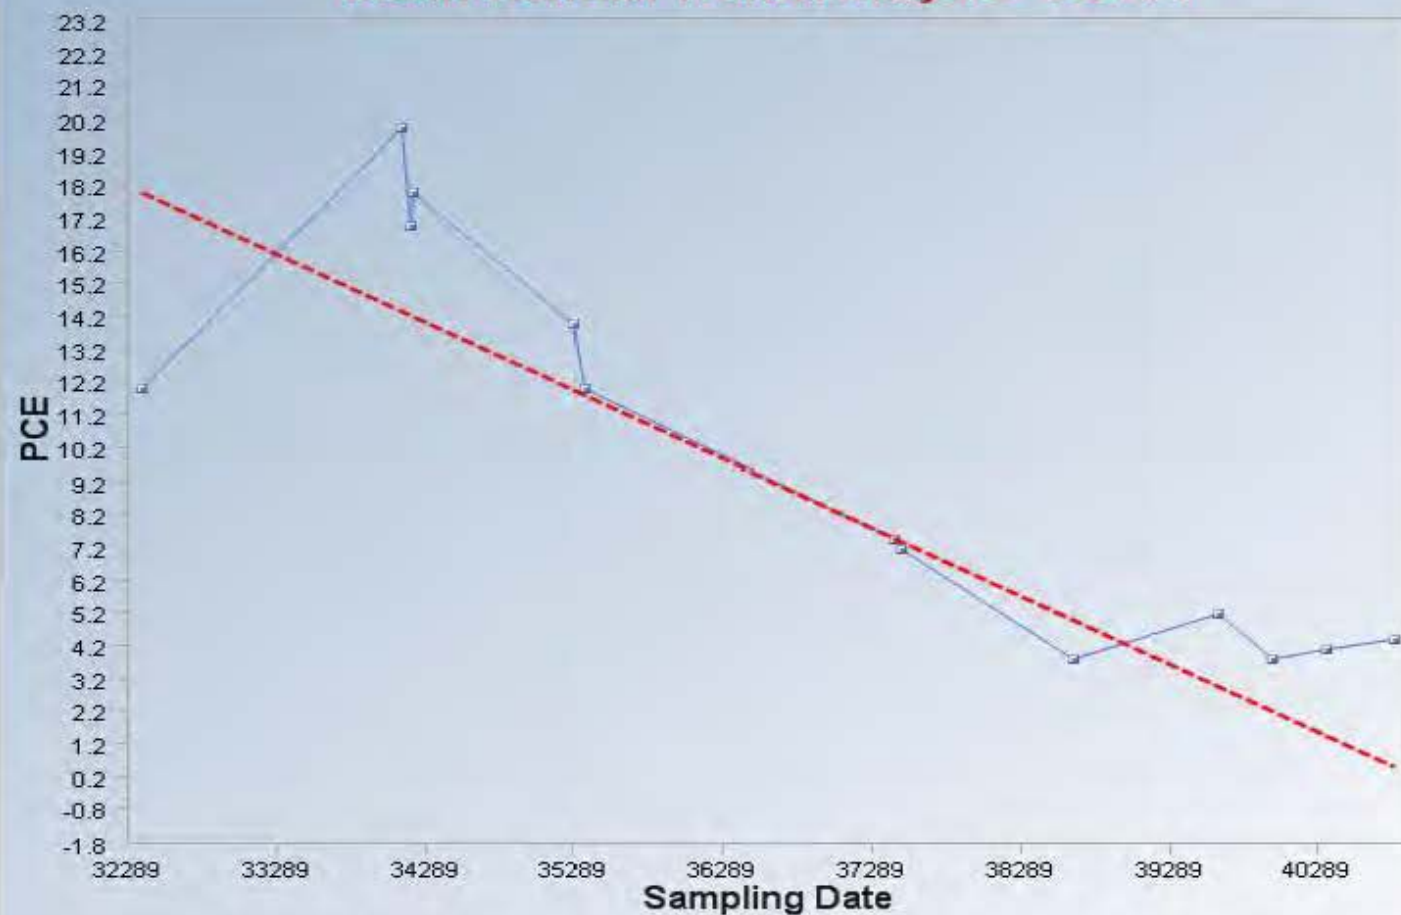
## Mann-Kendall Trend Analysis - IS6-01

n	13.0000
Confidence Coefficient	0.9500
Level of Significance	0.0500
Test Value (S)	-54
Tabulated p-value	0.0000
Standard Deviation of S	16.3299
Standardized Value of S	-3.2456
Approximate p-value	0.0006

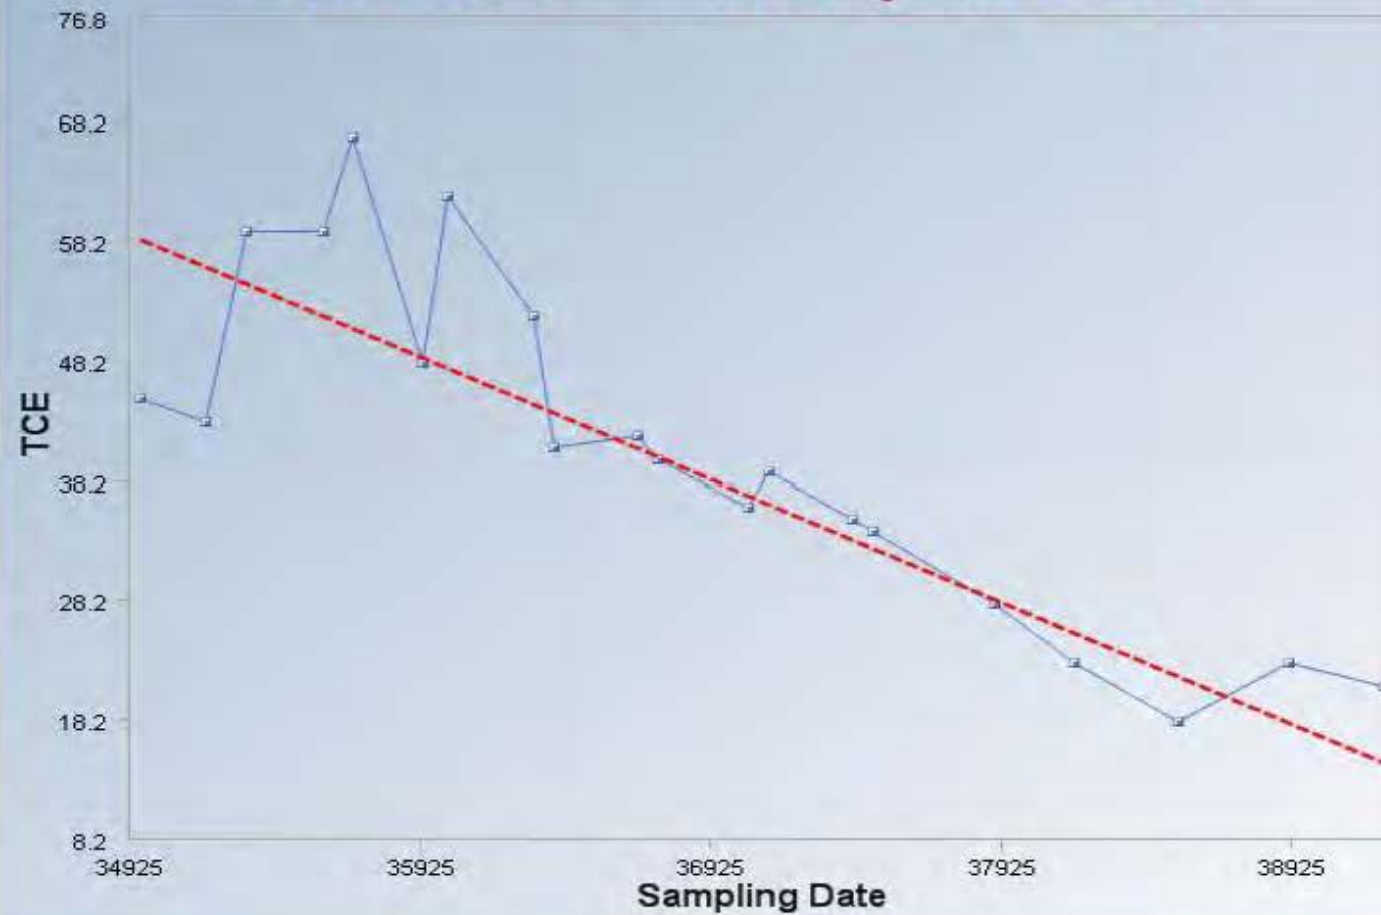
## Mann-Kendall Trend Analysis - 49WL-01

n	20.0000
Confidence Coefficient	0.9500
Level of Significance	0.0500
Test Value (S)	-144
Tabulated p-value	0.0000
Standard Deviation of S	30.7896
Standardized Value of S	-4.6444
Approximate p-value	0.0000

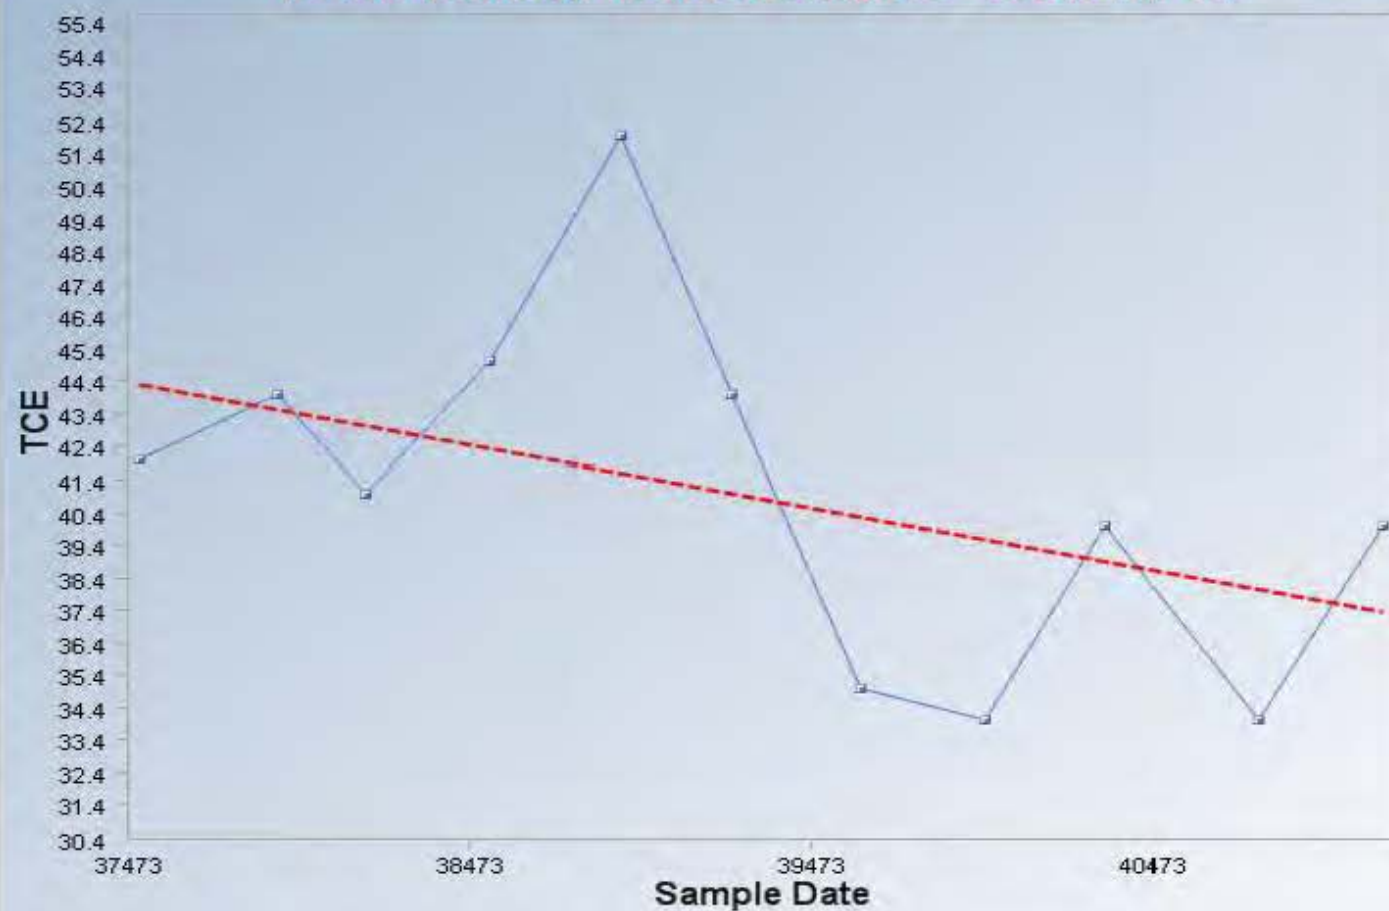
## Mann-Kendall Trend Analysis - OU5MW-34

n	11.0000
Confidence Coefficient	0.9500
Level of Significance	0.0500
Test Value (S)	-22
Tabulated p-value	0.0430
Standard Deviation of S	12.7279
Standardized Value of S	-1.6499
Approximate p-value	0.0495

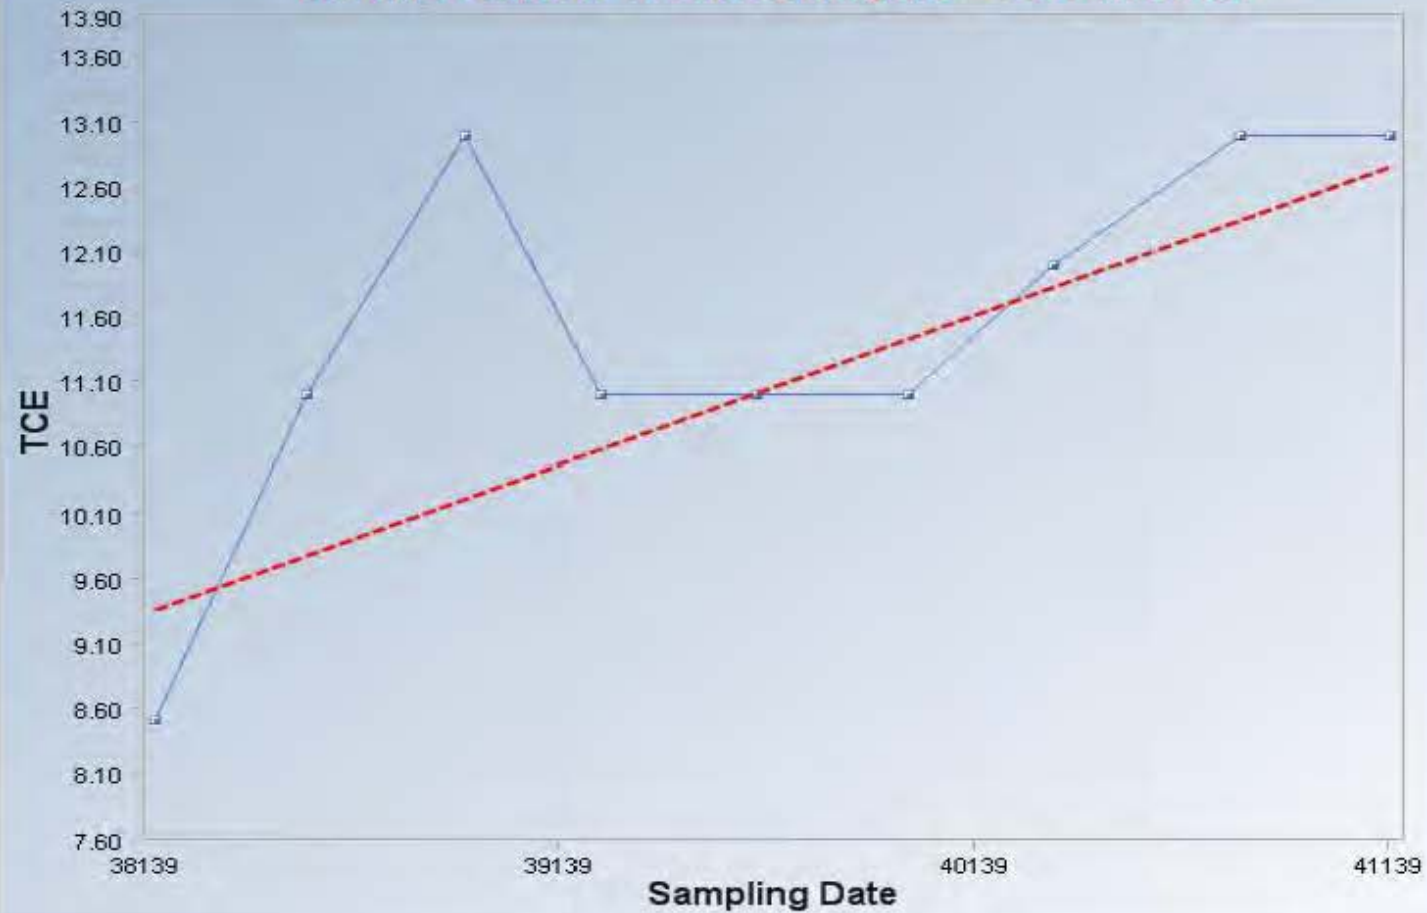
### Mann-Kendall Trend Analysis - OU5MW-38

n	9.0000
Confidence Coefficient	0.9500
Level of Significance	0.0500
Test Value (S)	19
Tabulated p-value	0.0380
Standard Deviation of S	8.9256
Standardized Value of S	2.0167
Approximate p-value	0.0219

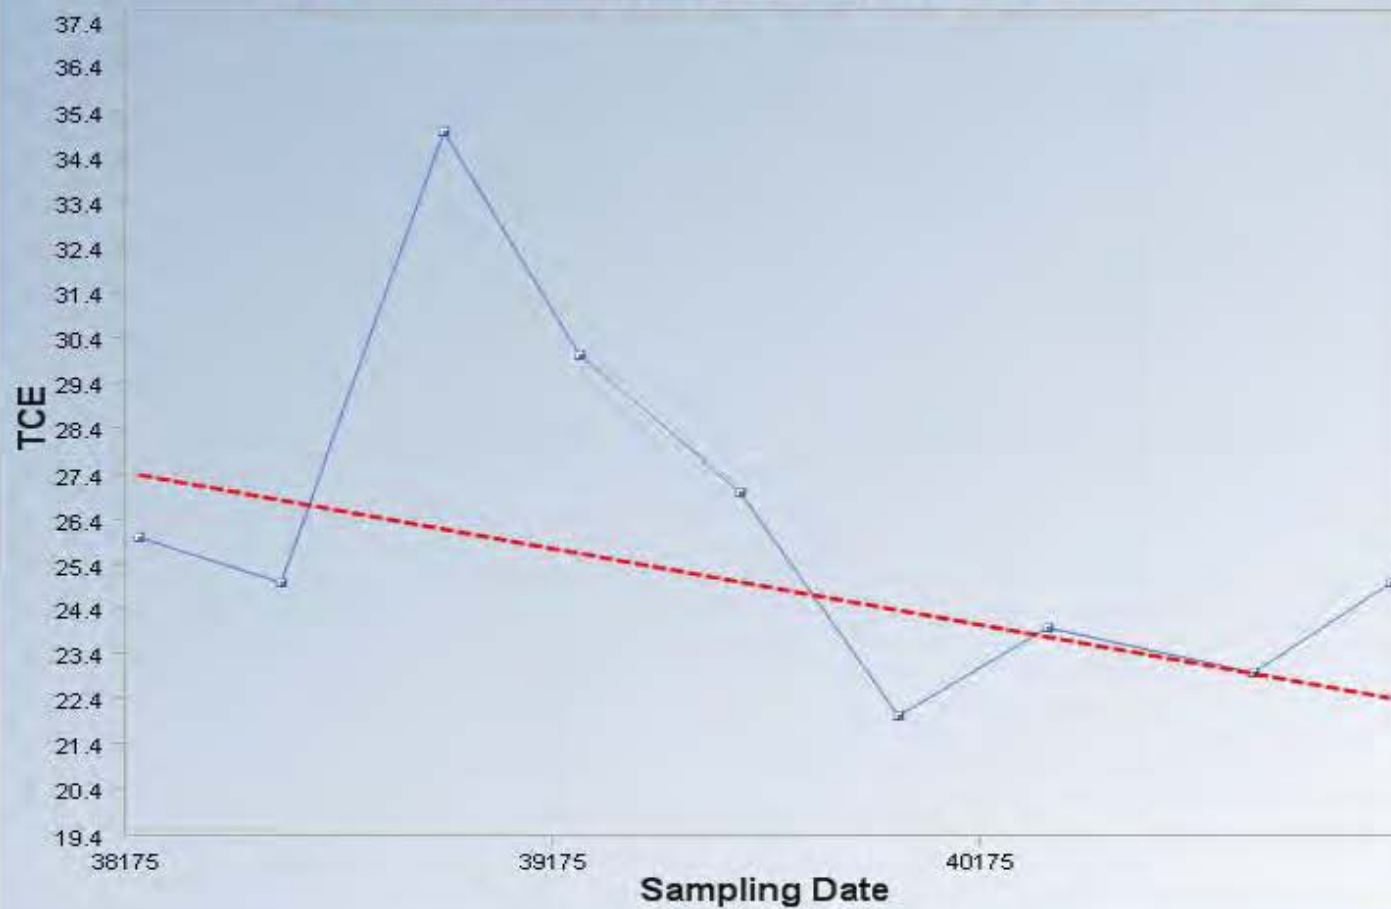
## Mann-Kendall Trend Analysis - OU5MW-44

n	9.0000
Confidence Coefficient	0.9500
Level of Significance	0.0500
Test Value (S)	-13
Tabulated p-value	0.1300
Standard Deviation of S	9.5394
Standardized Value of S	-1.2579
Approximate p-value	0.1042

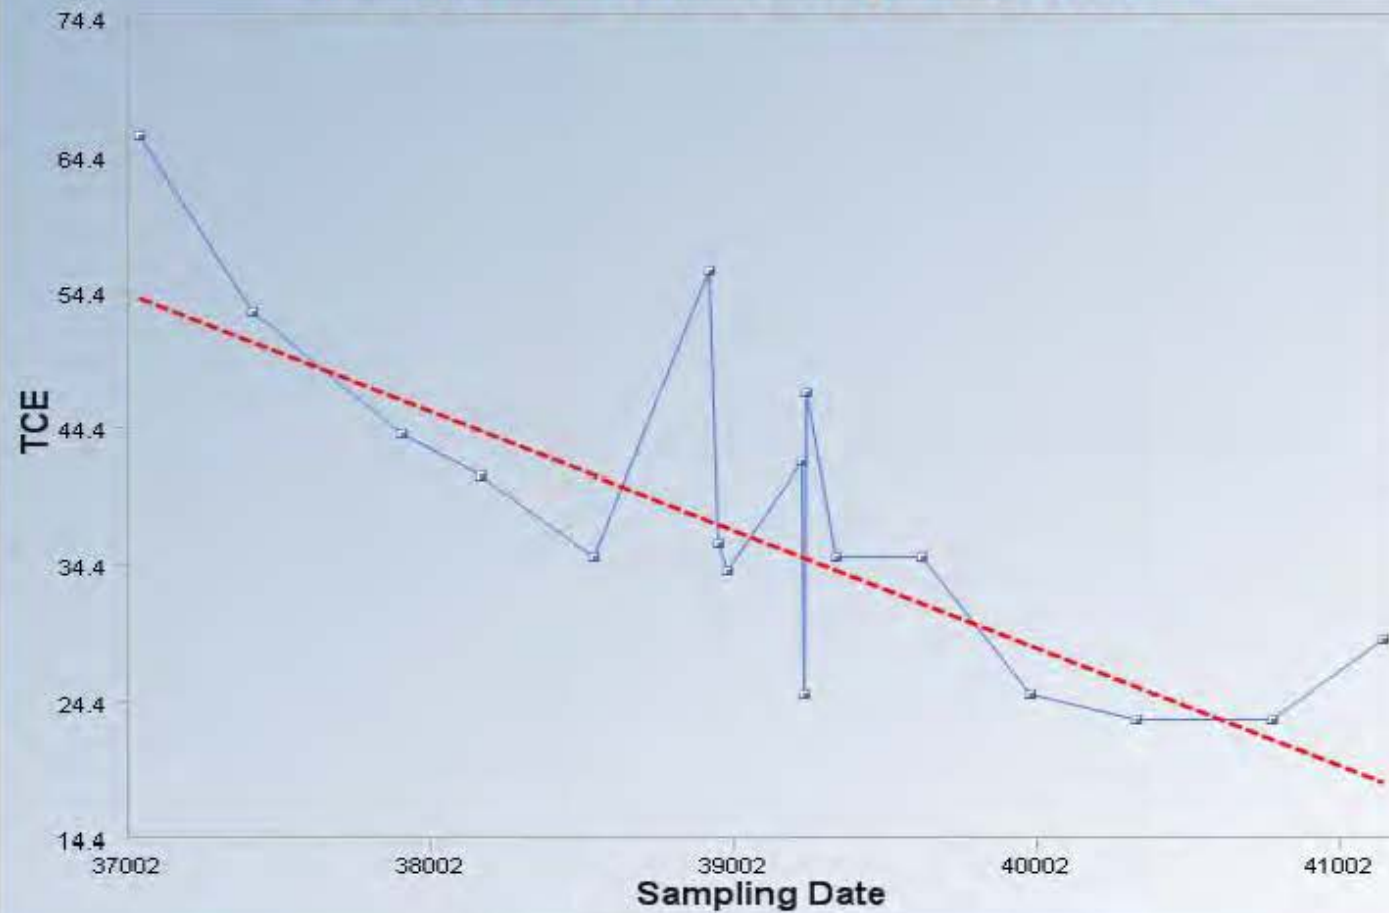
## Mann-Kendall Trend Analysis - 403WL-01

n	17.0000
Confidence Coefficient	0.9500
Level of Significance	0.0500
Test Value (S)	-83
Tabulated p-value	0.0000
Standard Deviation of S	24.1592
Standardized Value of S	-3.3942
Approximate p-value	0.0003

Statistically significant evidence of a decreasing trend at the specified level of significance.

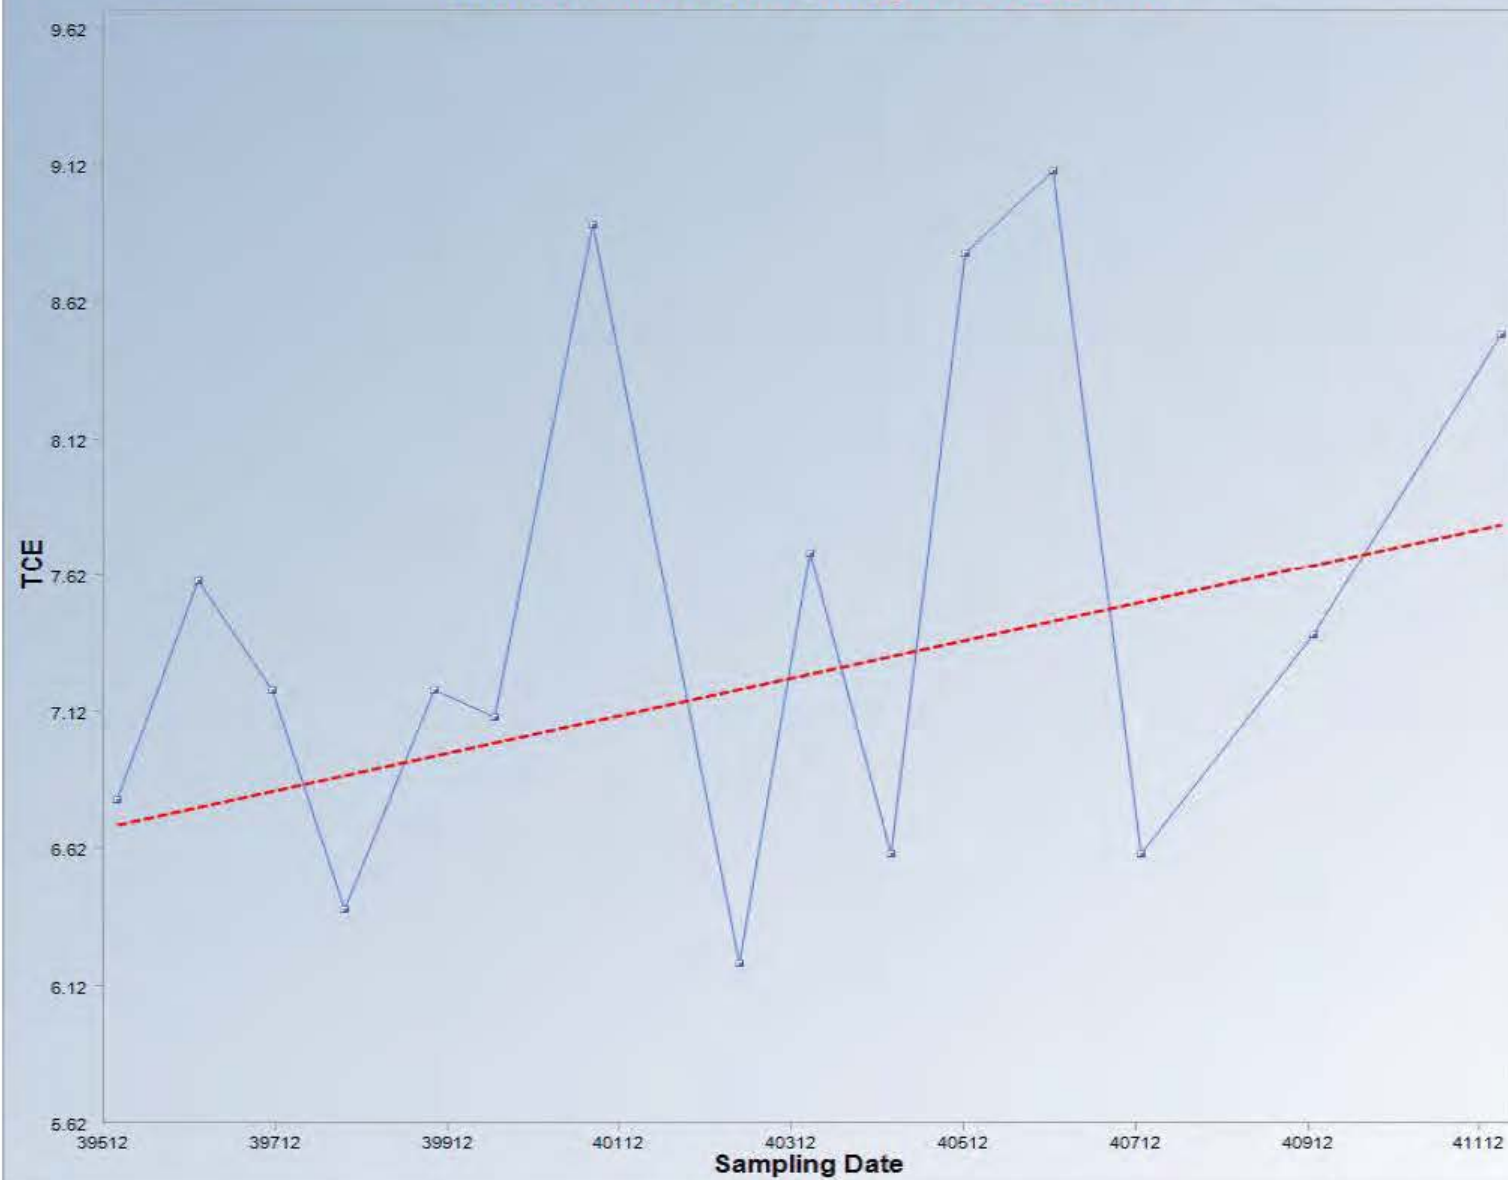
### Mann-Kendall Trend Analysis - OU5SP-10

n	15.0000
Confidence Coefficient	0.9500
Level of Significance	0.0500
Test Value (S)	21
Tabulated p-value	0.1640
Standard Deviation of S	20.1577
Standardized Value of S	0.9922
Approximate p-value	0.1606

Insufficient evidence to identify a significant trend at the specified level of significance.

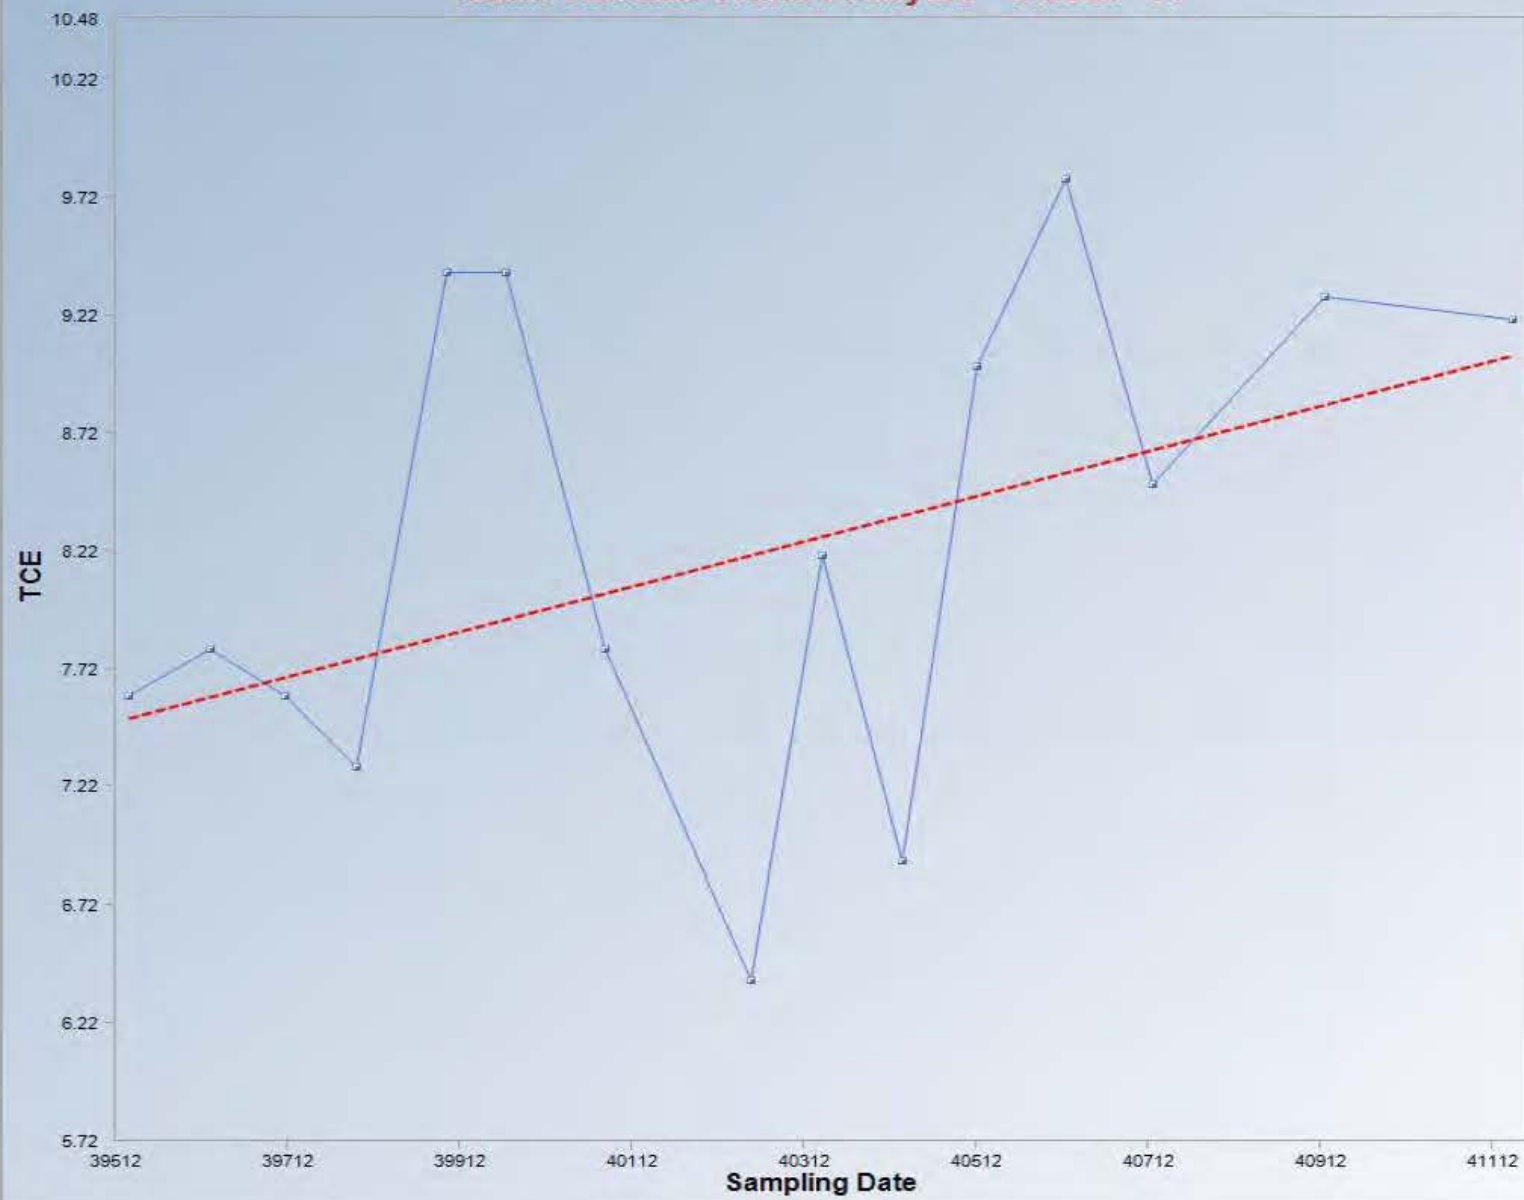
### Mann-Kendall Trend Analysis - OU5SP-11

n	15.0000
Confidence Coefficient	0.9500
Level of Significance	0.0500
Test Value (S)	30
Tabulated p-value	0.0700
Standard Deviation of S	20.1329
Standardized Value of S	1.4404
Approximate p-value	0.0749

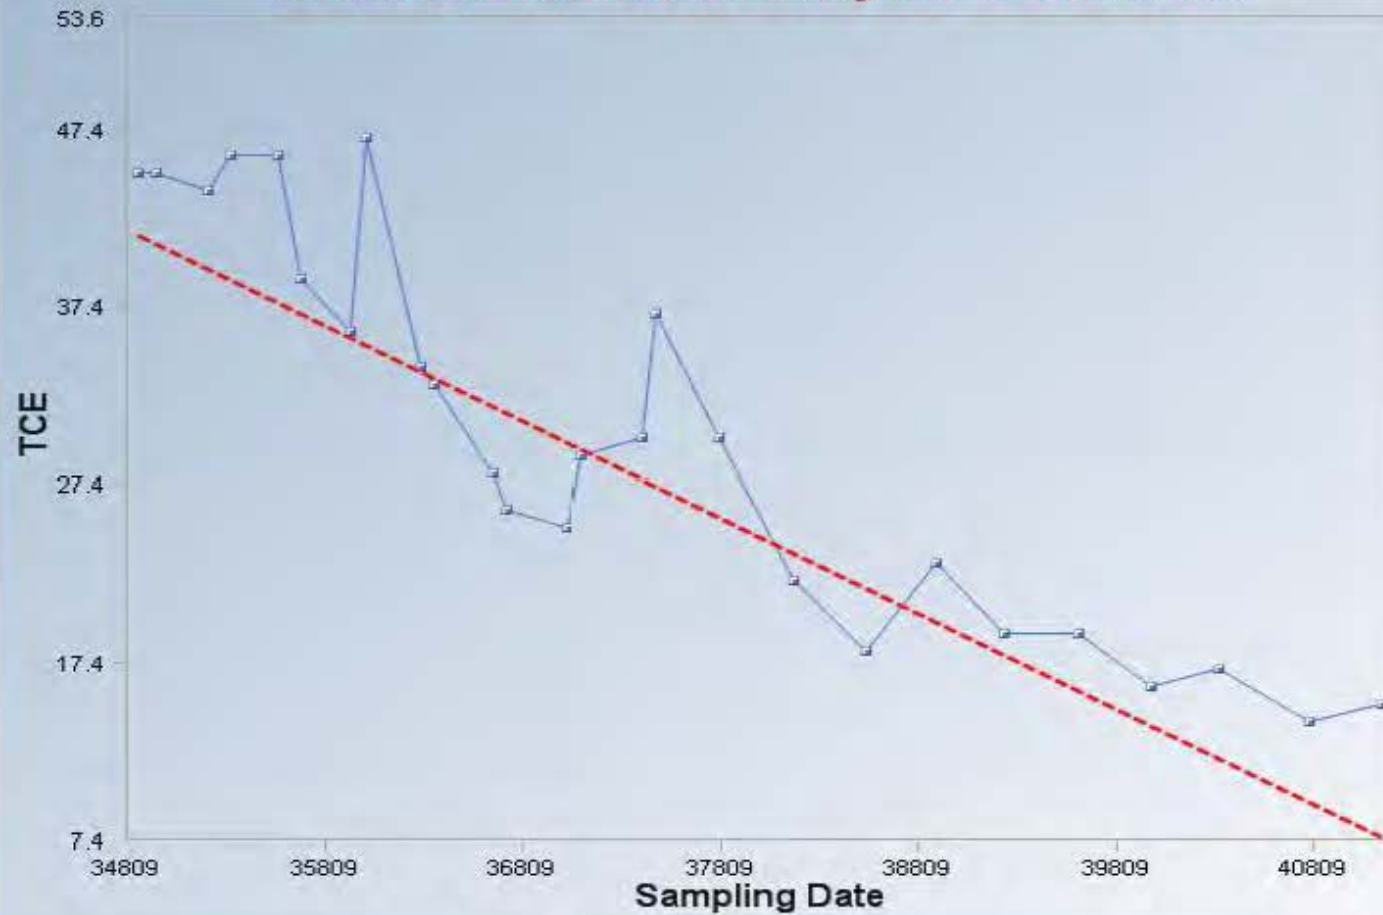
## Mann-Kendall Trend Analysis - OU5MW-06

n	26.0000
Confidence Coefficient	0.9500
Level of Significance	0.0500
Test Value (S)	-245
Critical Value (0.05)	-1.6449
Standard Deviation of S	45.3248
Standardized Value of S	-5.3834
Approximate p-value	0.0000

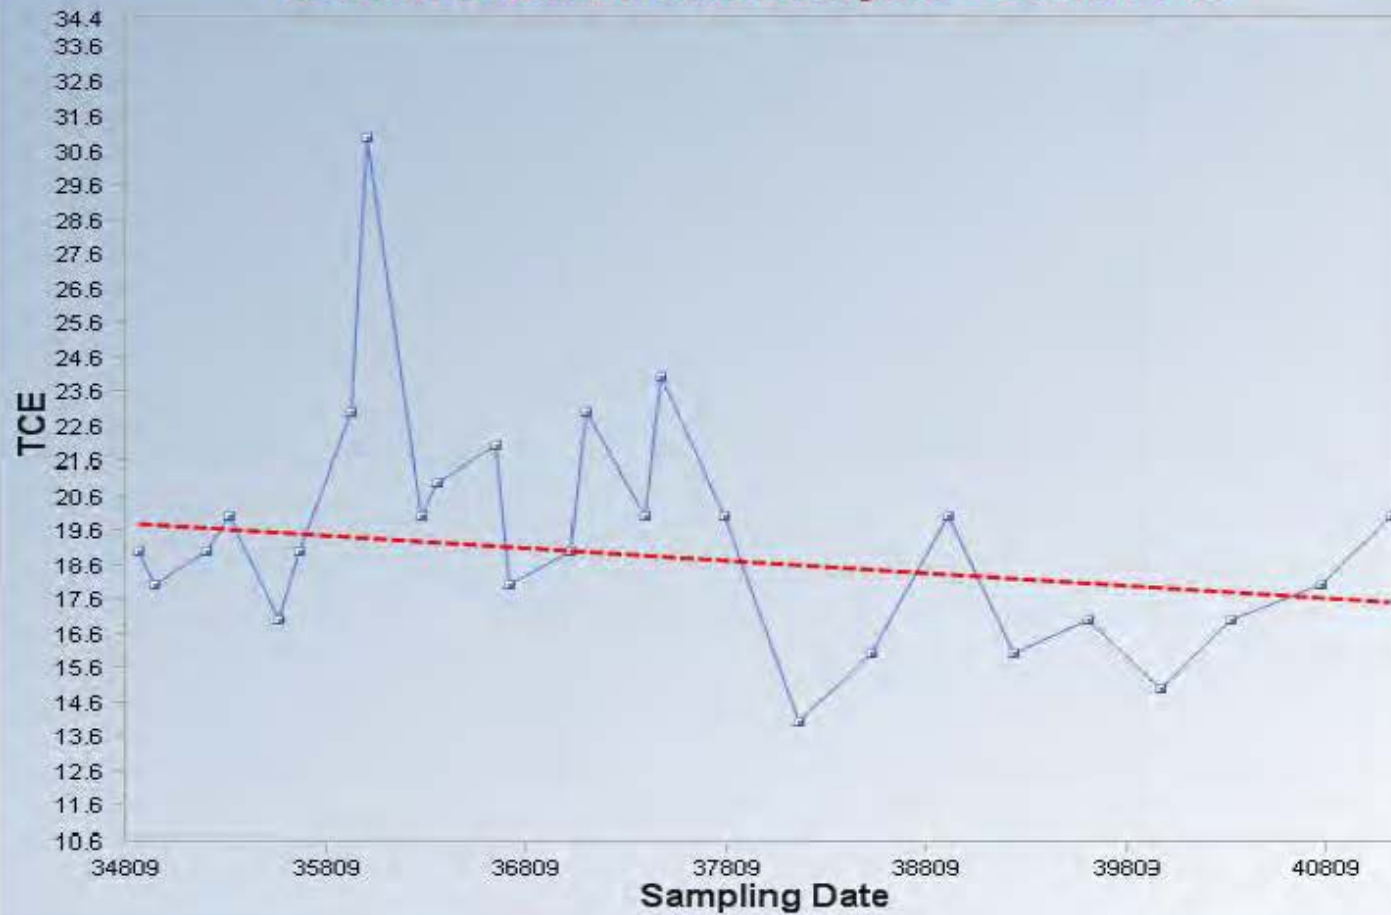
## Mann-Kendall Trend Analysis - OU5MW-07

n	26.0000
Confidence Coefficient	0.9500
Level of Significance	0.0500
Test Value (S)	-52
Critical Value (0.05)	-1.6449
Standard Deviation of S	44.8553
Standardized Value of S	-1.1370
Approximate p-value	0.1278

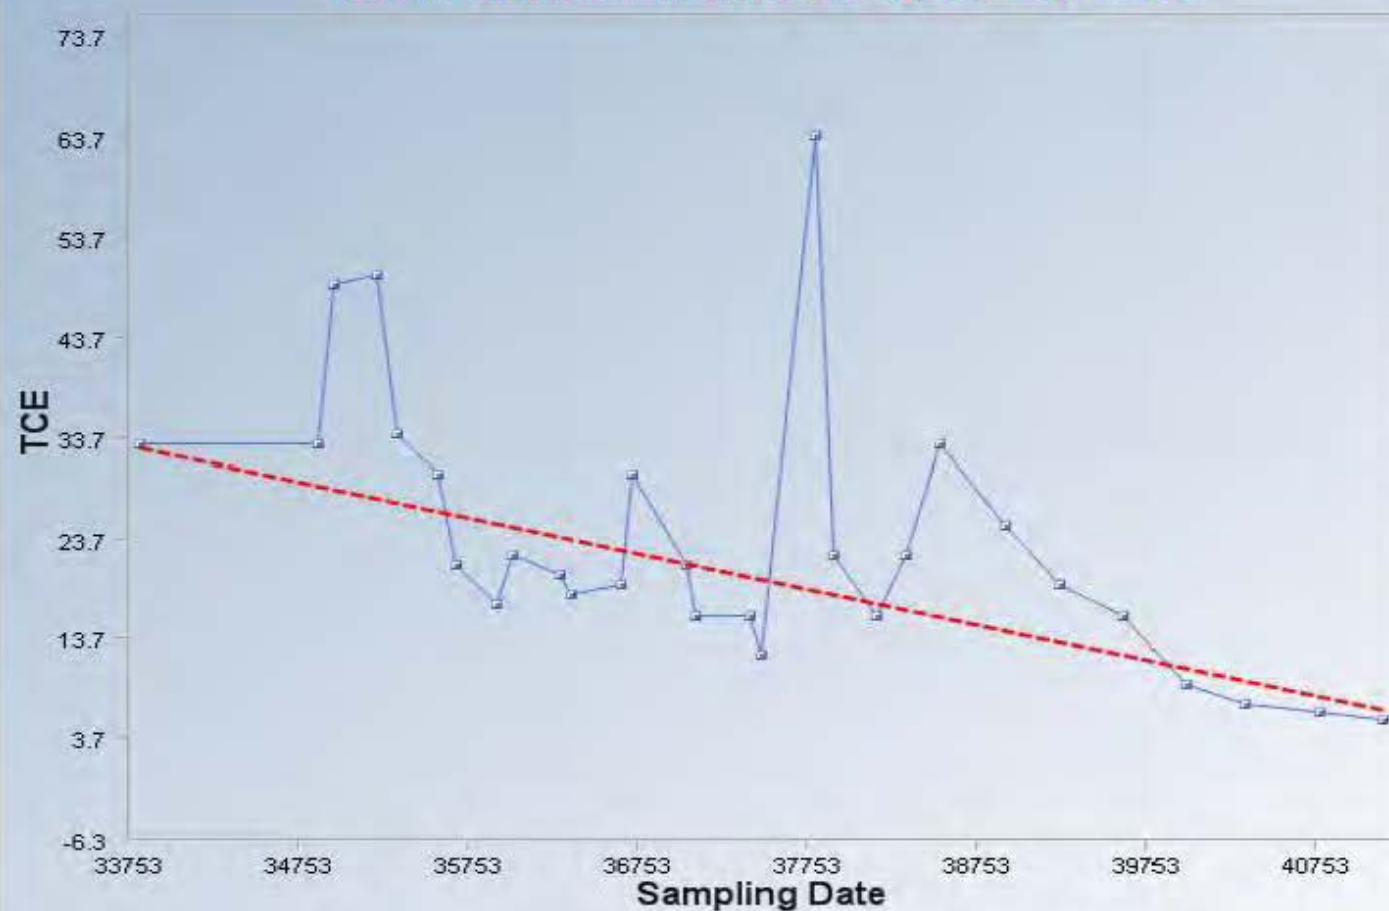
## Mann-Kendall Trend Analysis - SP1-02

n	29.0000
Confidence Coefficient	0.9500
Level of Significance	0.0500
Test Value (S)	-201
Critical Value (0.05)	-1.6449
Standard Deviation of S	53.1319
Standardized Value of S	-3.7642
Approximate p-value	0.0001

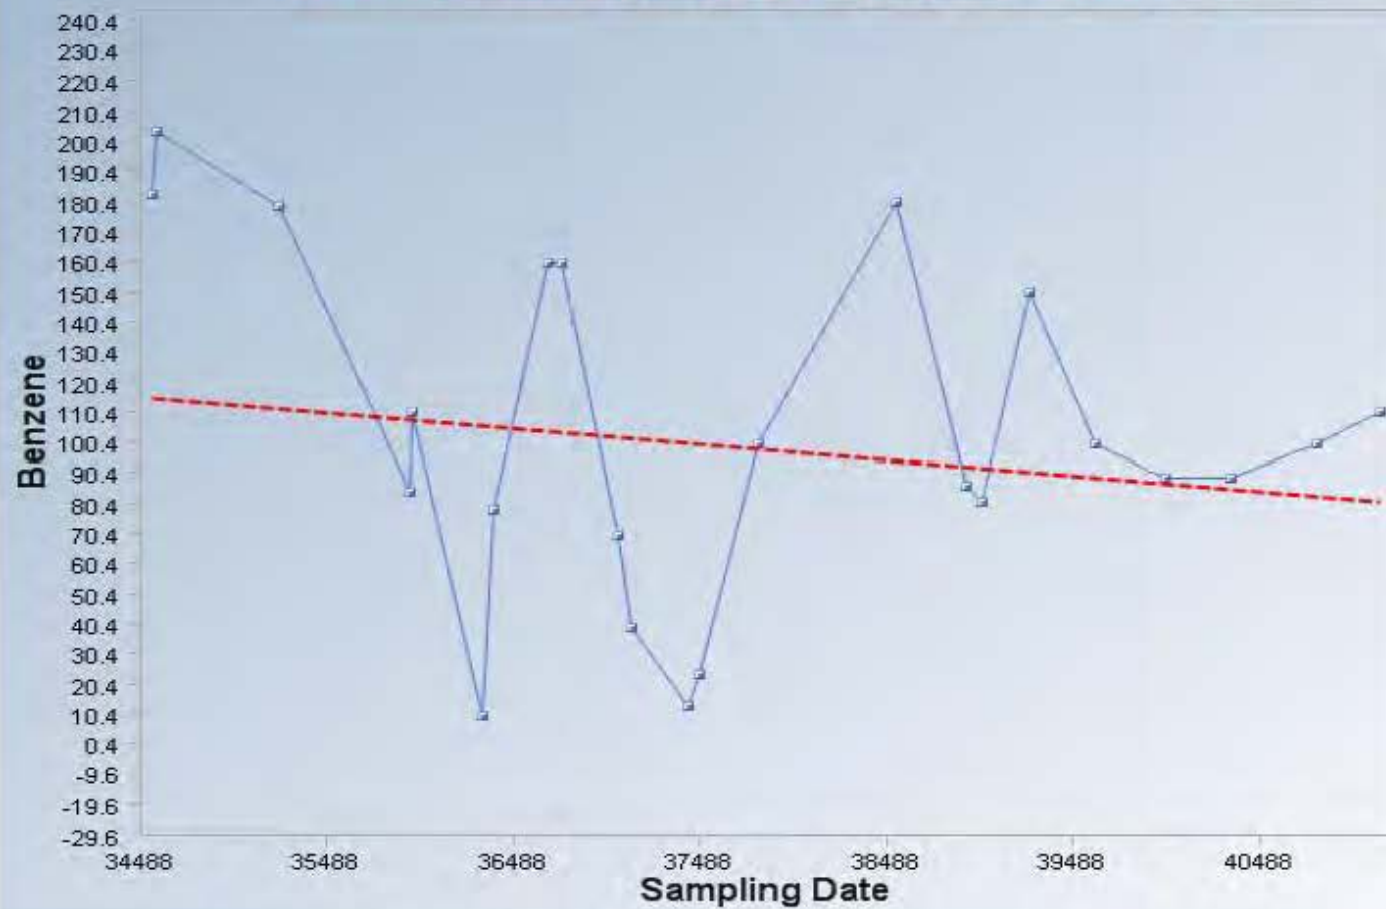
## Mann-Kendall Trend Analysis - OU6MW-17

n	23.0000
Confidence Coefficient	0.9500
Level of Significance	0.0500
Test Value (S)	-25
Critical Value (0.05)	-1.6449
Standard Deviation of S	37.7757
Standardized Value of S	-0.6353
Approximate p-value	0.2626

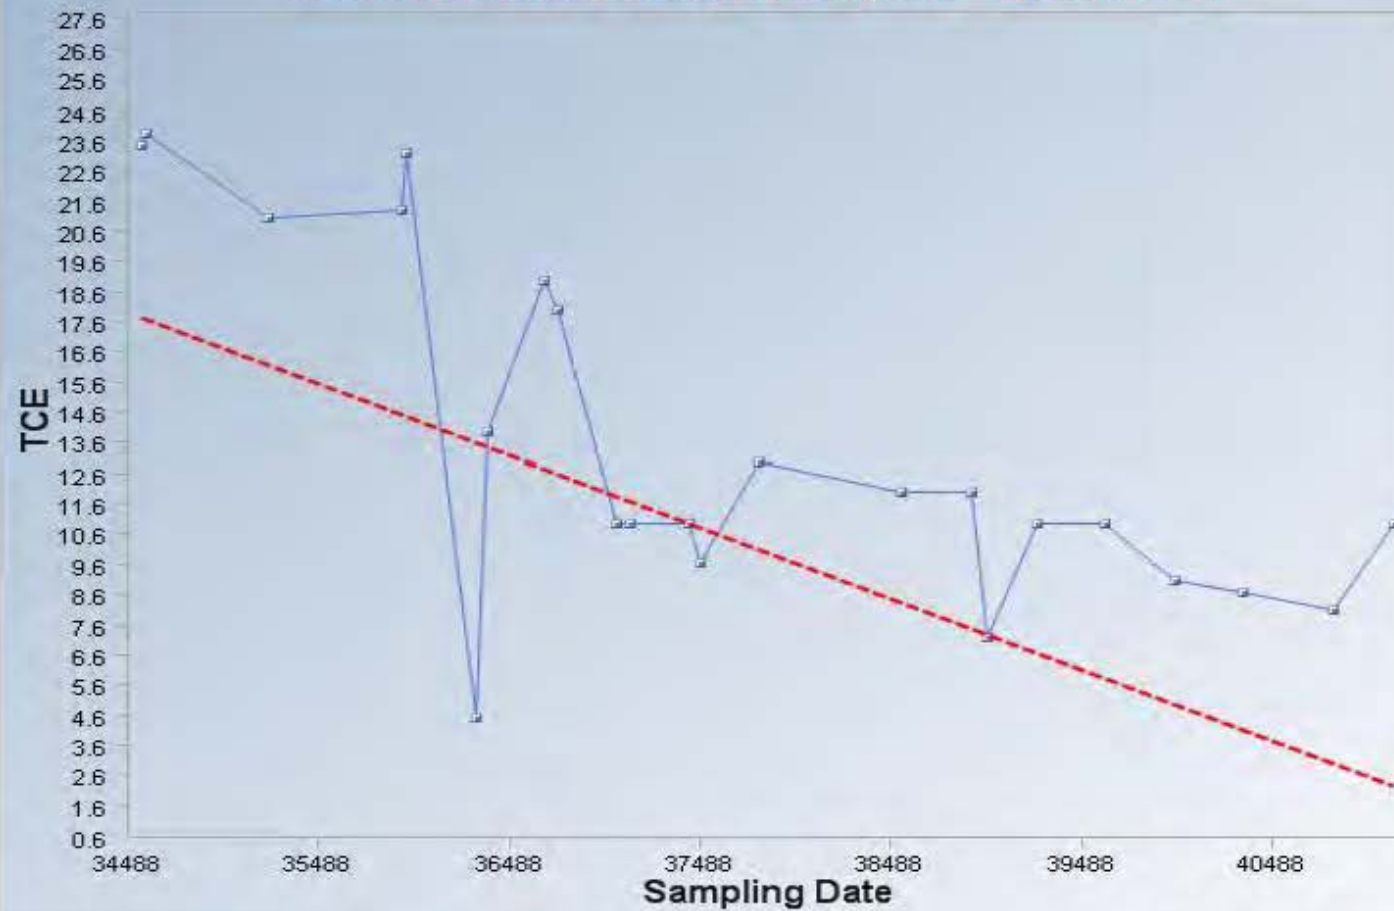
## Mann-Kendall Trend Analysis - OU6MW-17

n	23.0000
Confidence Coefficient	0.9500
Level of Significance	0.0500
Test Value (S)	-143
Critical Value (0.05)	-1.6449
Standard Deviation of S	37.4744
Standardized Value of S	-3.7892
Approximate p-value	0.0001
